Research Bulletin 364

Farm Fence End and Corner Design

BY HENRY GIESE AND S. MILTON HENDERSON

AGRICULTURAL EXPERIMENT STATION
IOWA STATE COLLEGE OF AGRICULTURE
AND MECHANIC ARTS

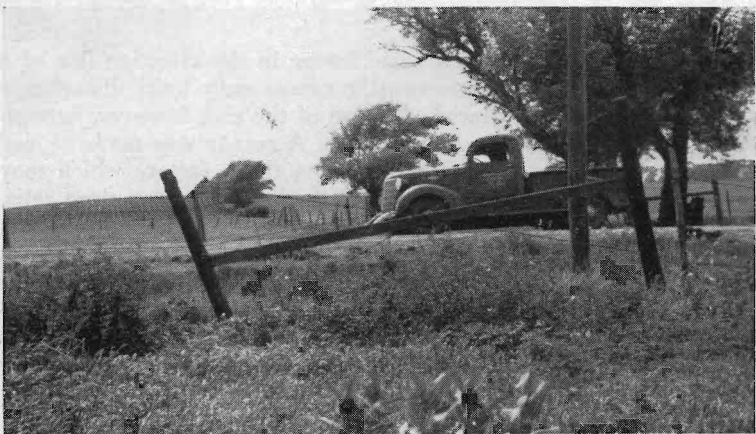
Fig. 2. Failure resulting from insufficient depth of set.

The length of span in fig. 2 was approximately 11 feet. There were only three barbwires fastened to the end post. The end post

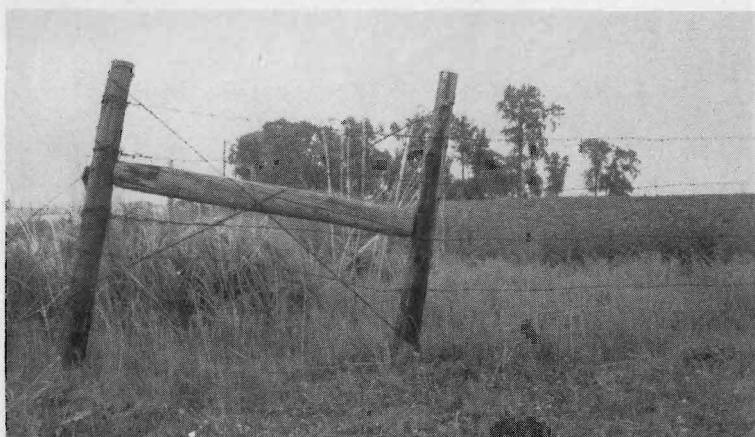
Fig. 4. Failure of a short span.

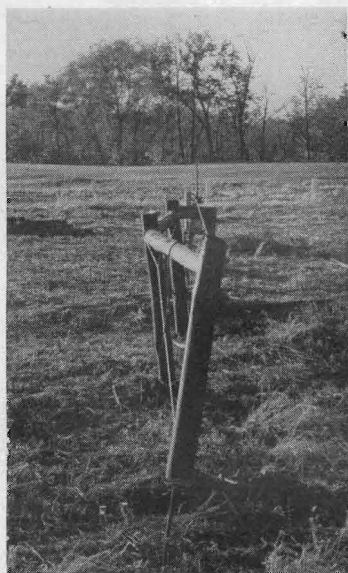
Fig. 52. Characteristic failure of double span assembly.
